UNITED STATES ENVIRONMENTAL PROTECTION AGENCY
REGION 2
290 BROADWAY
NEW YORK, NY 10007-1866

Re: Phillips 66 Co., Bayway Refinery, Linden NJ
EPA/NJDEP NJPDES Permit Compliance Evaluation Inspection June 12, 13, and 20, 2019
NJPDES Permit No. NJ0001511 (NJPID No. 46318), NJ0026671 (NJPID No. 46322)

Enclosure – Inspection Report from June 2019 CEI

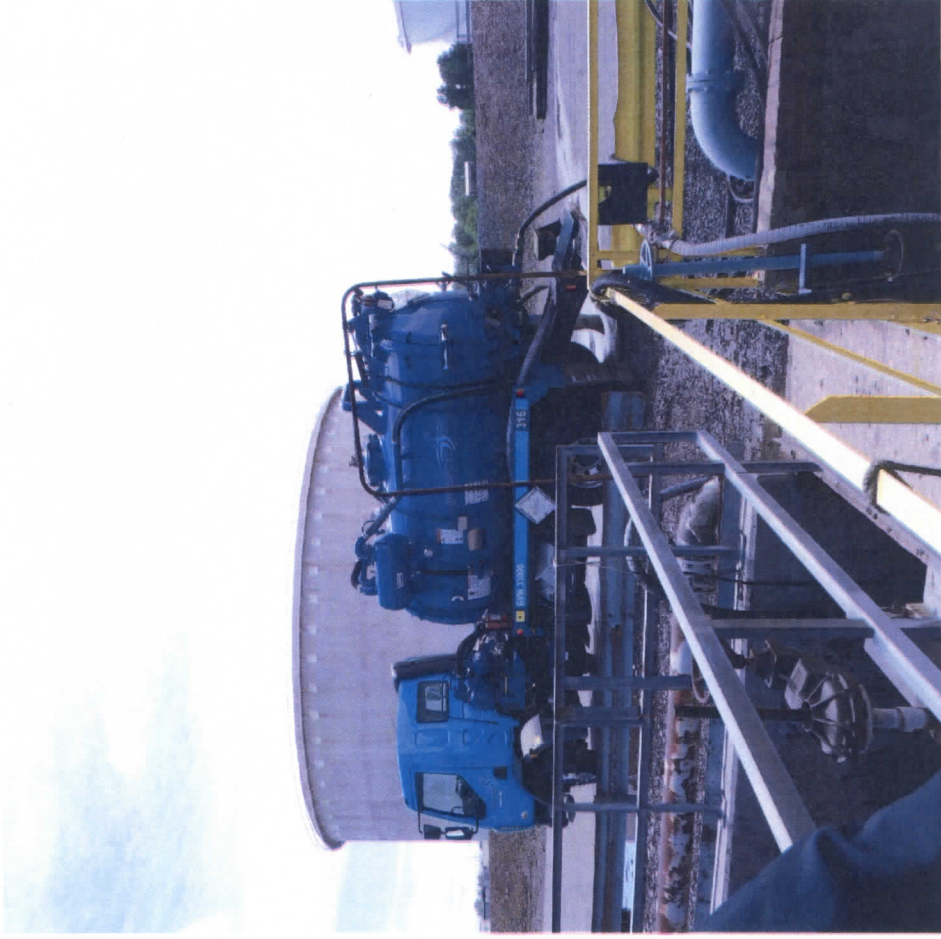
DSCN6770 – oil on top of Infineum API separator

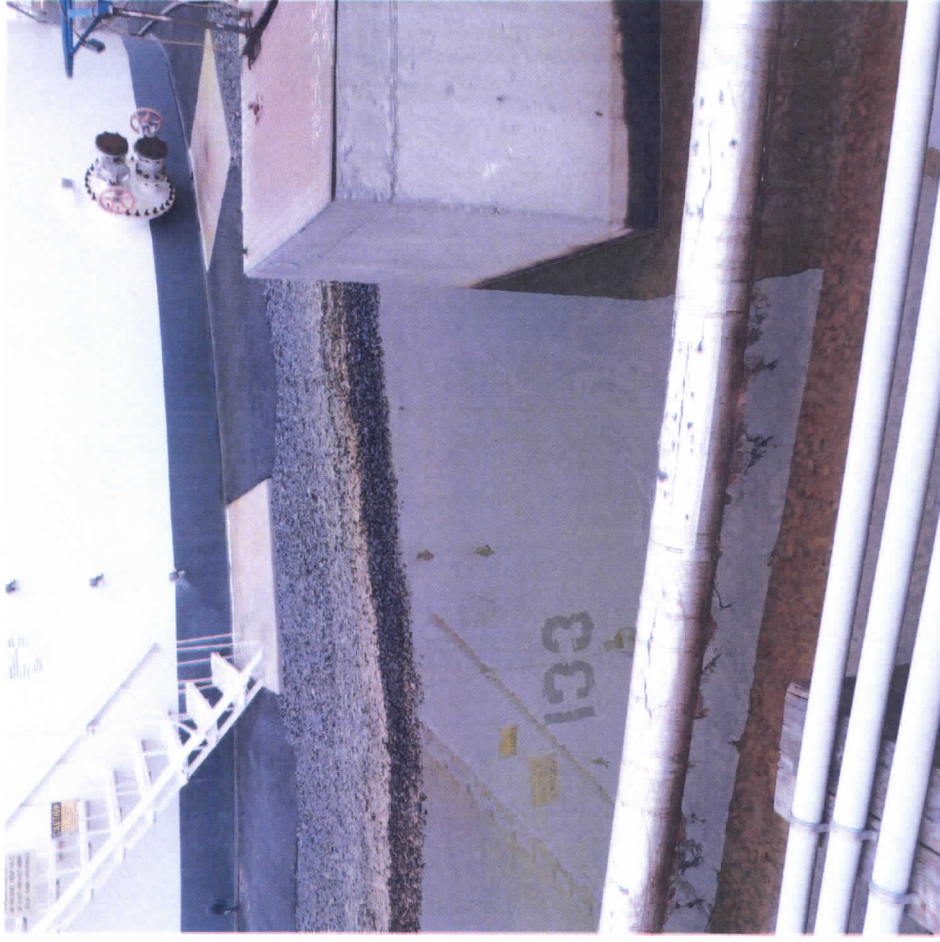
DSCN6774 – sludge dewatering operation

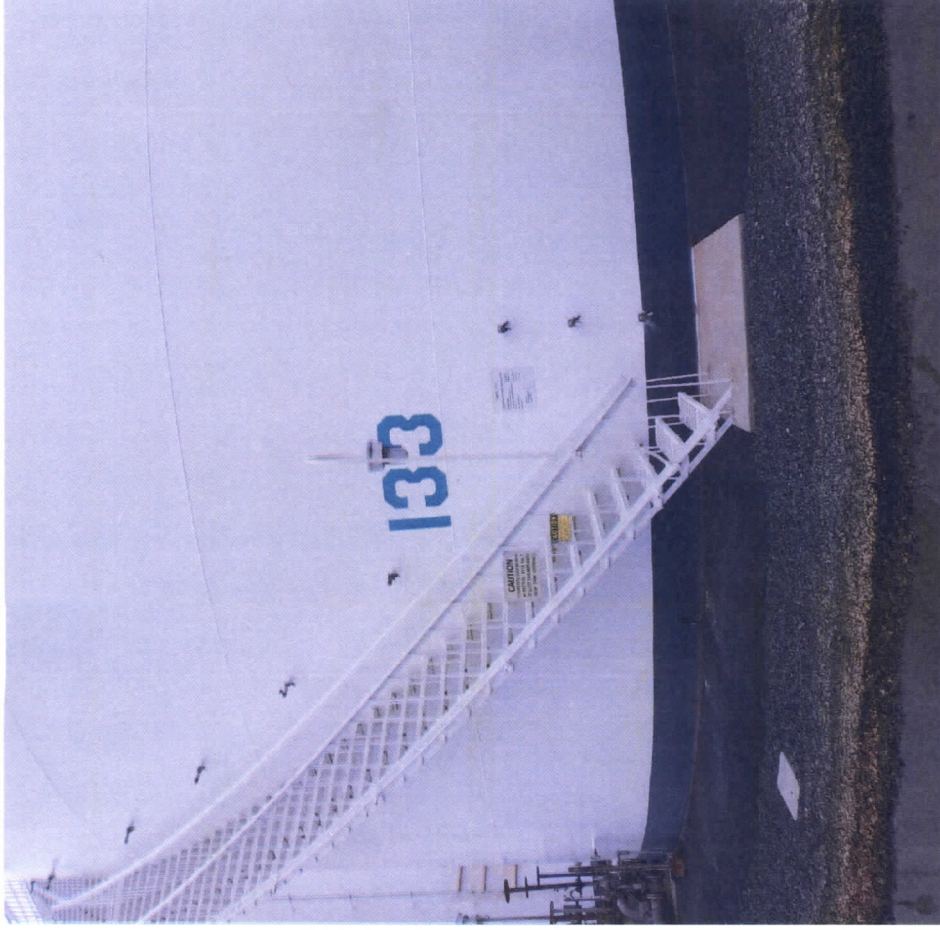
DSCN6775 – oily water in the tank 133 tank dike

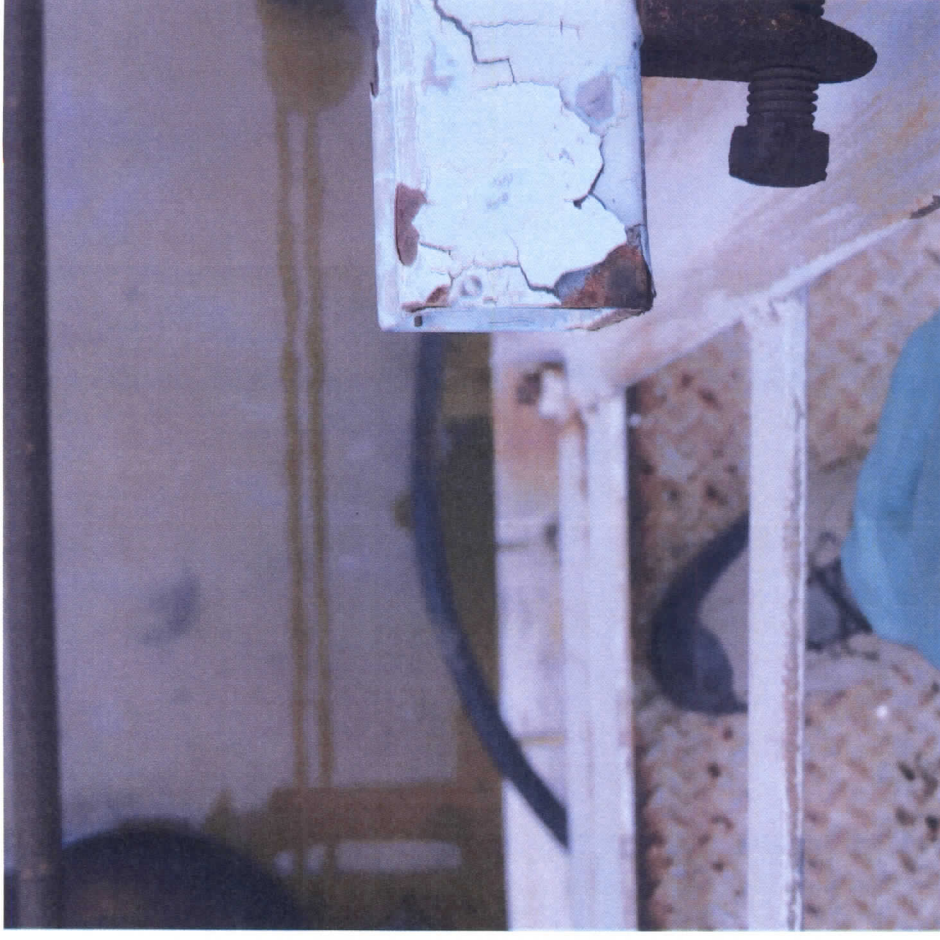
DSCN6776 - oily water in the tank 133 tank dike

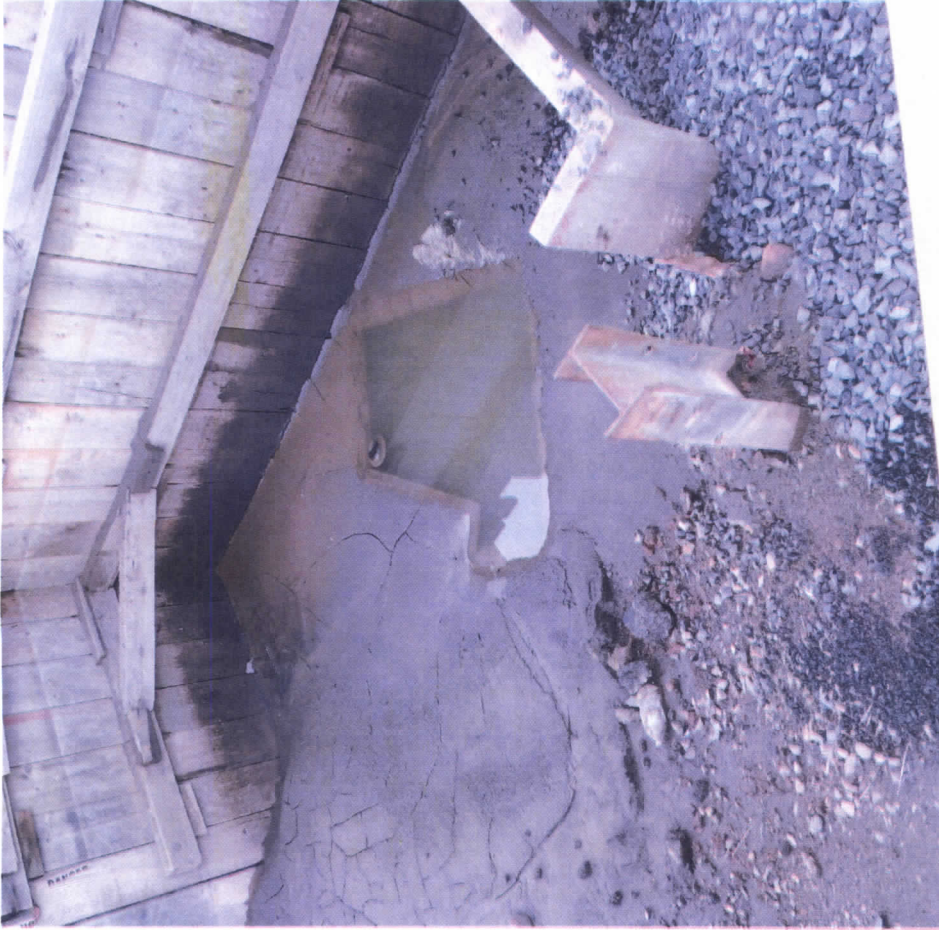
DSCN6777 - sheen on tank 133 dike

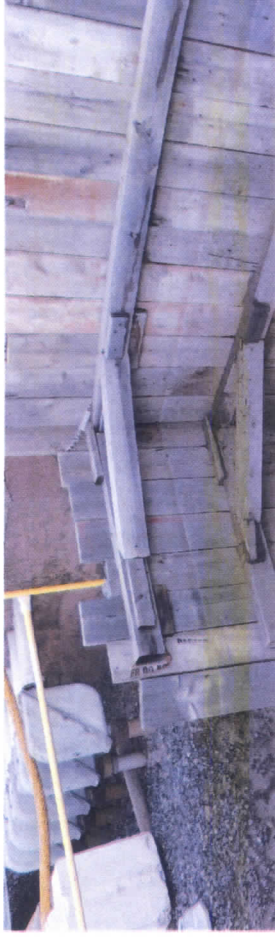
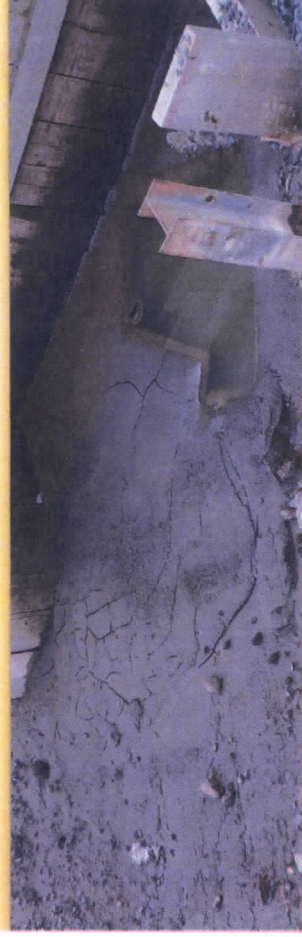
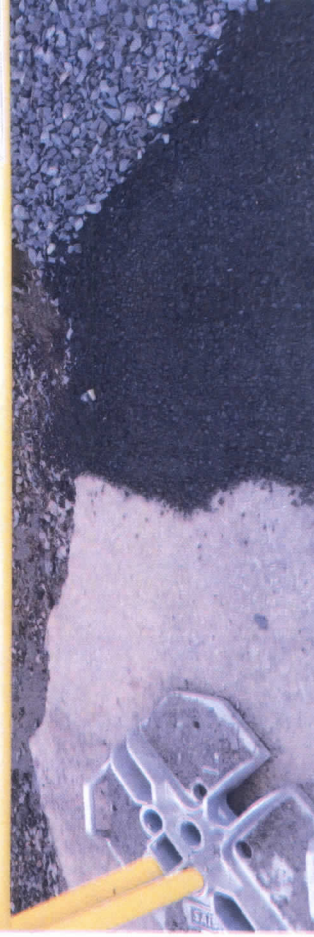
DSCN6778 – Valve Break on the tank 133/132 dike, and
said valve in open position

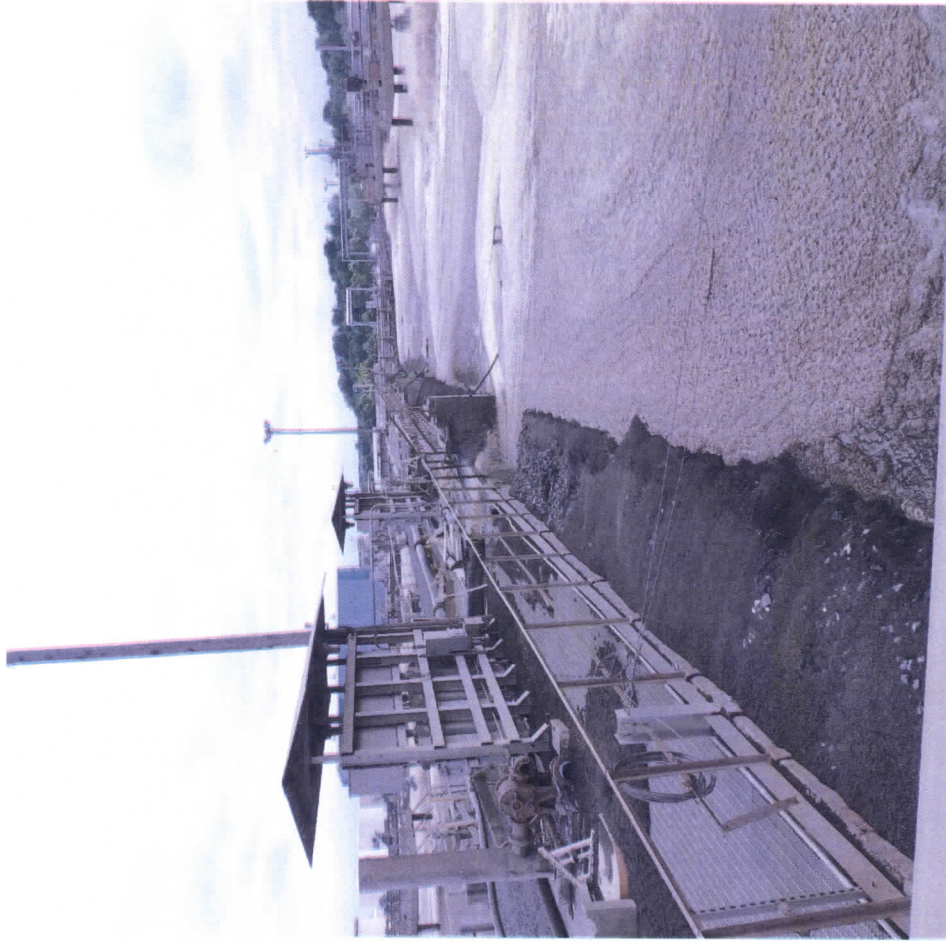
DSCN6783 – temporary piping setup for Return Activated Sludge (RAS)

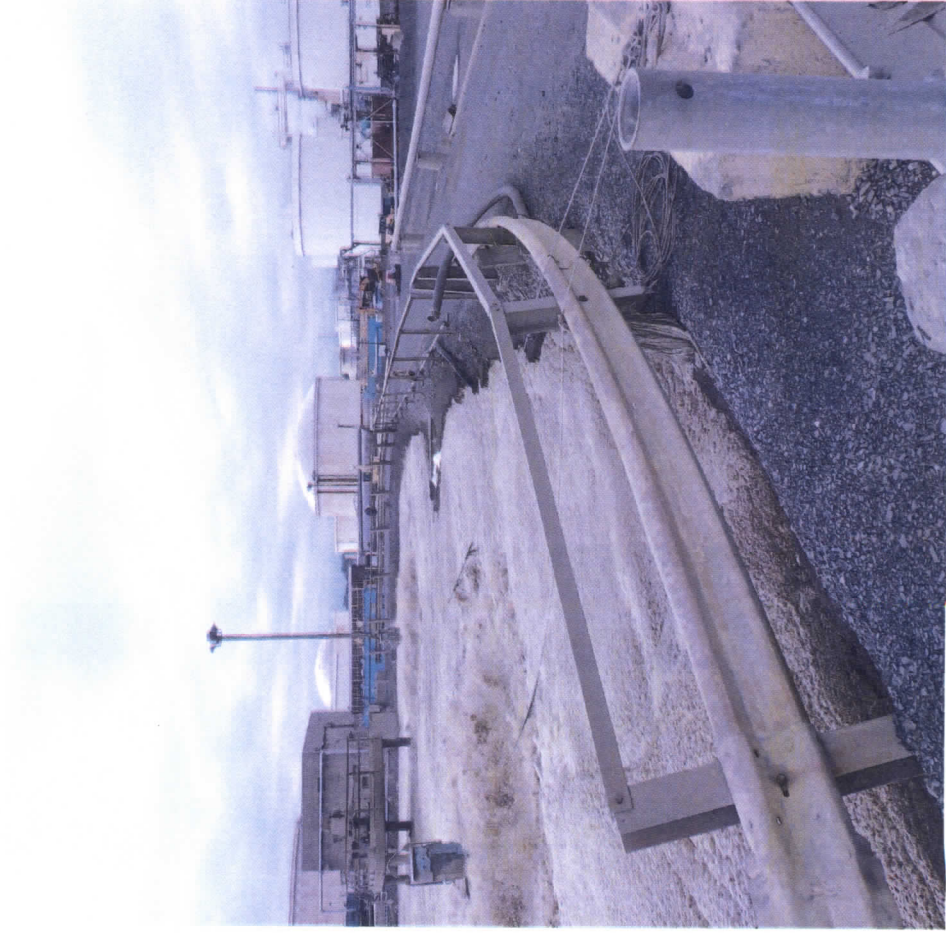
DSCN6785 - Foaming at BiOx Lagoon

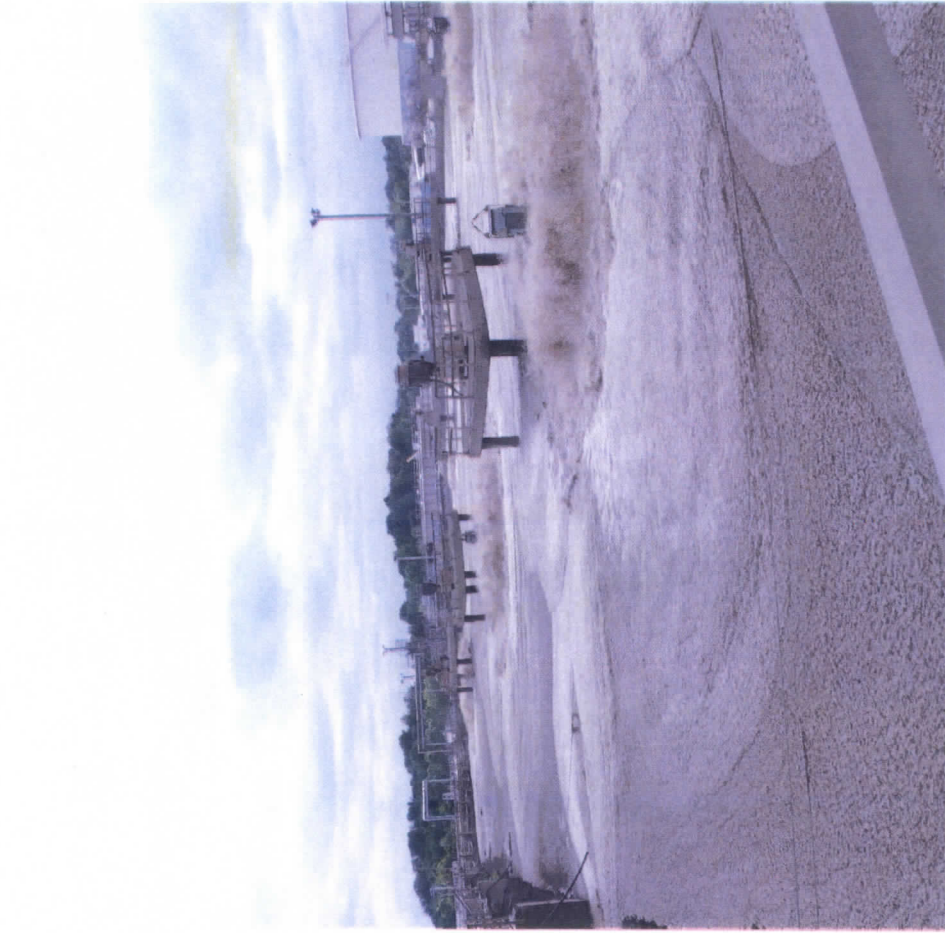
DSCN6784 - Foaming at BiOx Lagoon

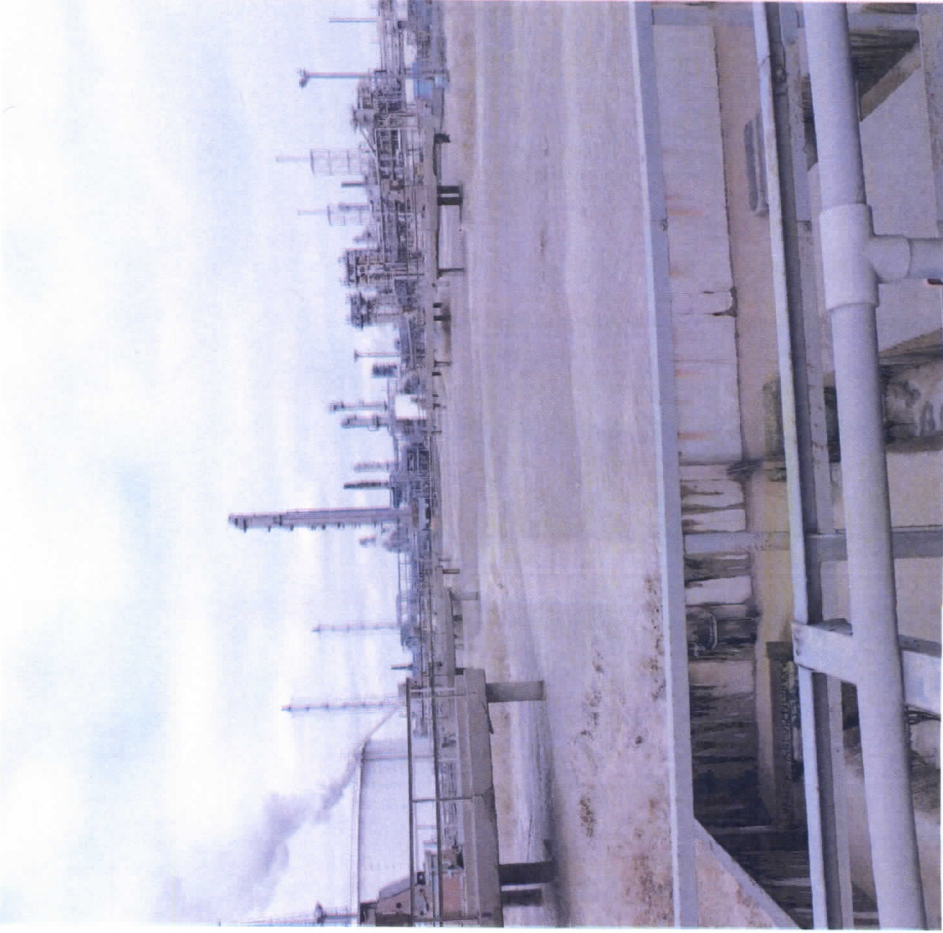
DSCN6787 – floating solids/foam near the Biox effluent

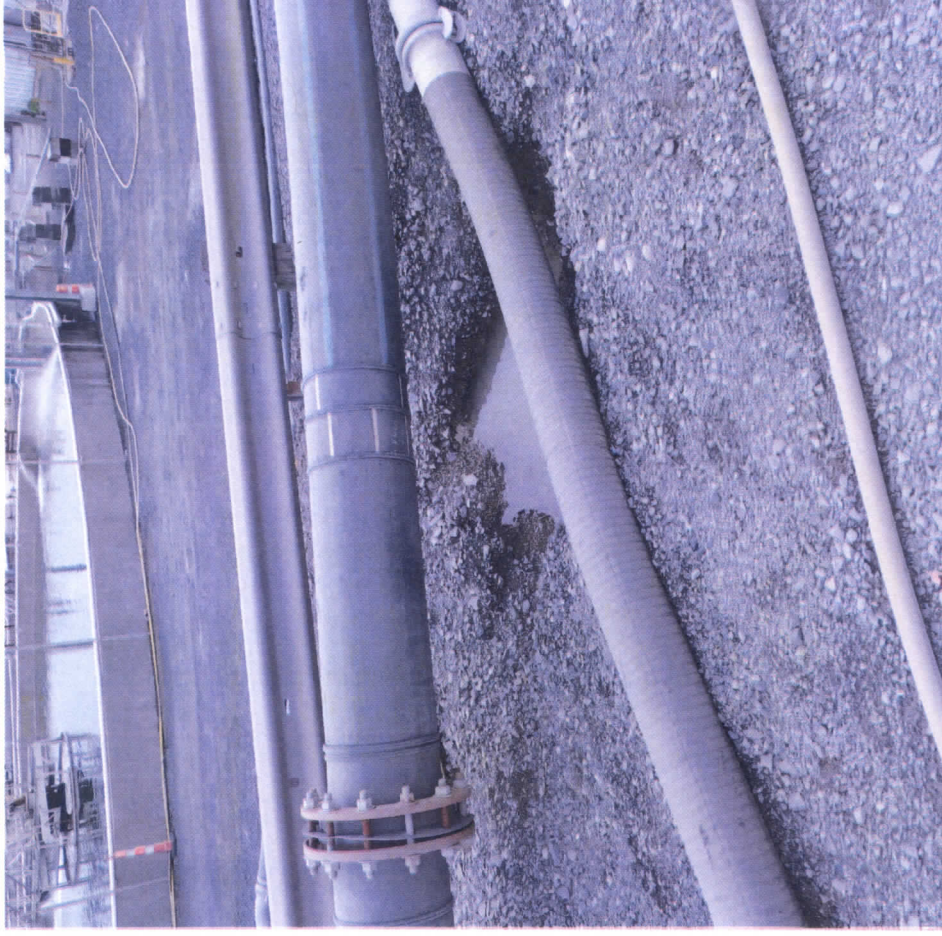
DSCN6790 – Diesel pumps set up for pumping Return Activated Sludge

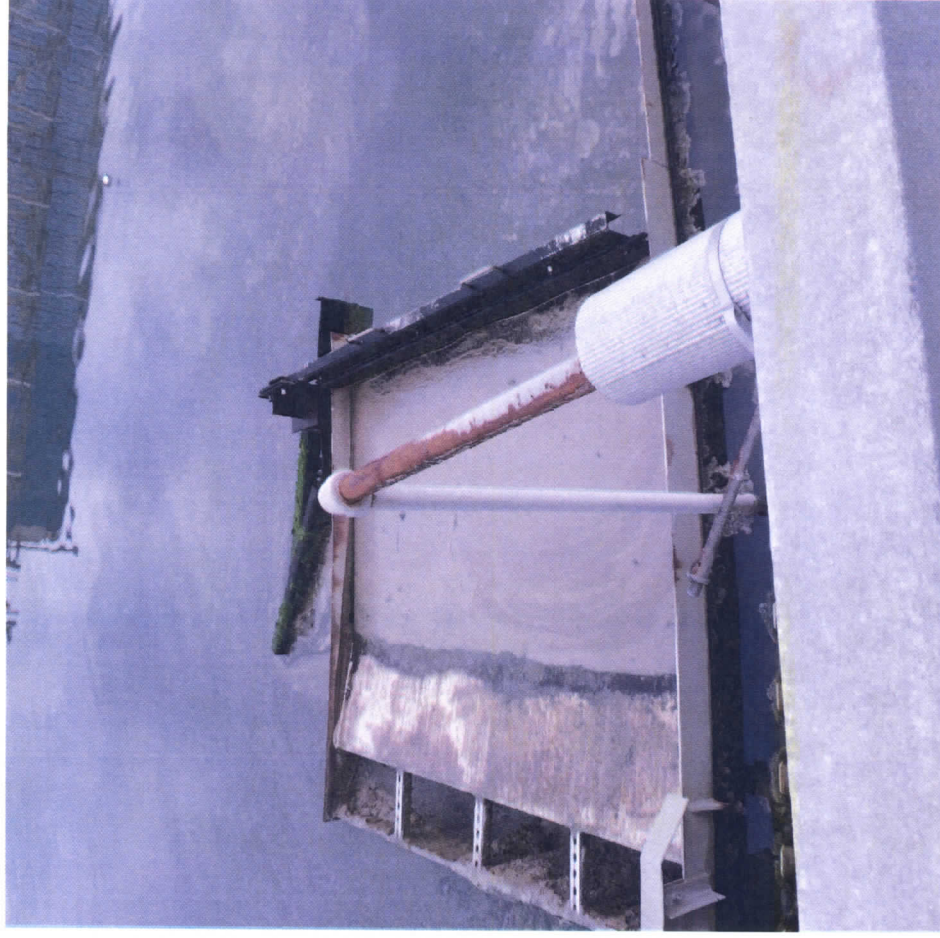
DSCN6792 – scum collection rake. Water sprays are seen on the clarifier

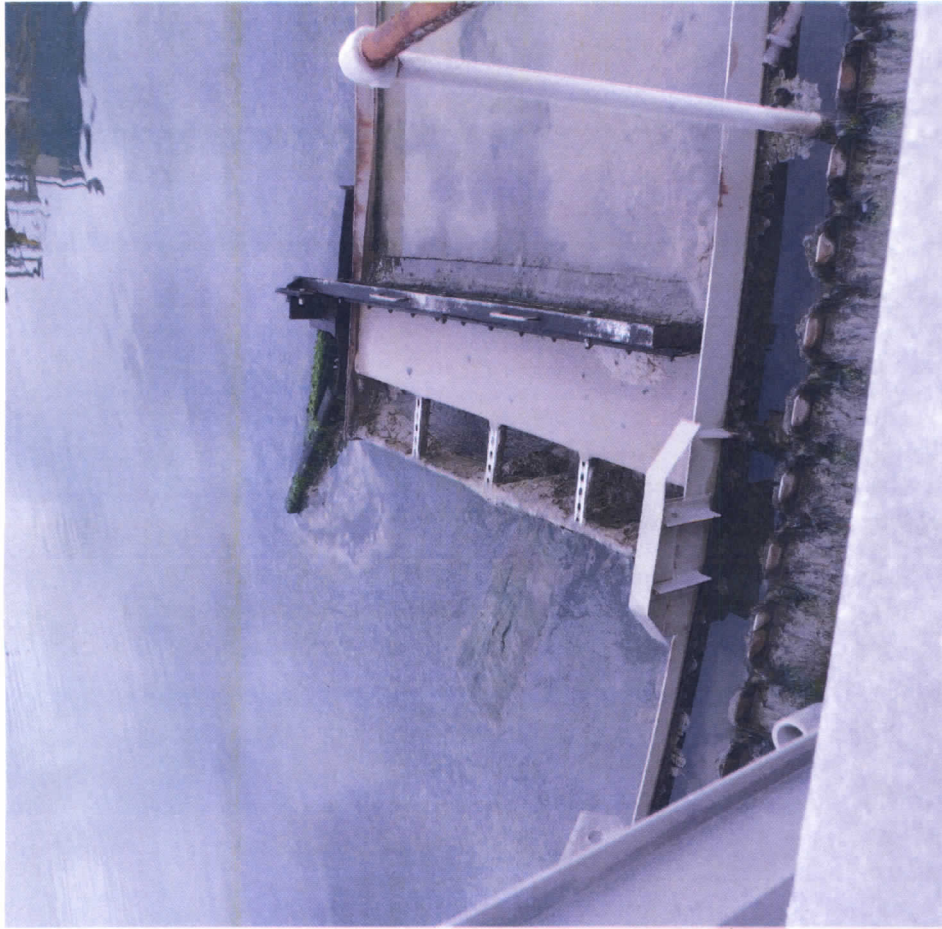
DSCN6793 – scum being collected in the final clarifiers

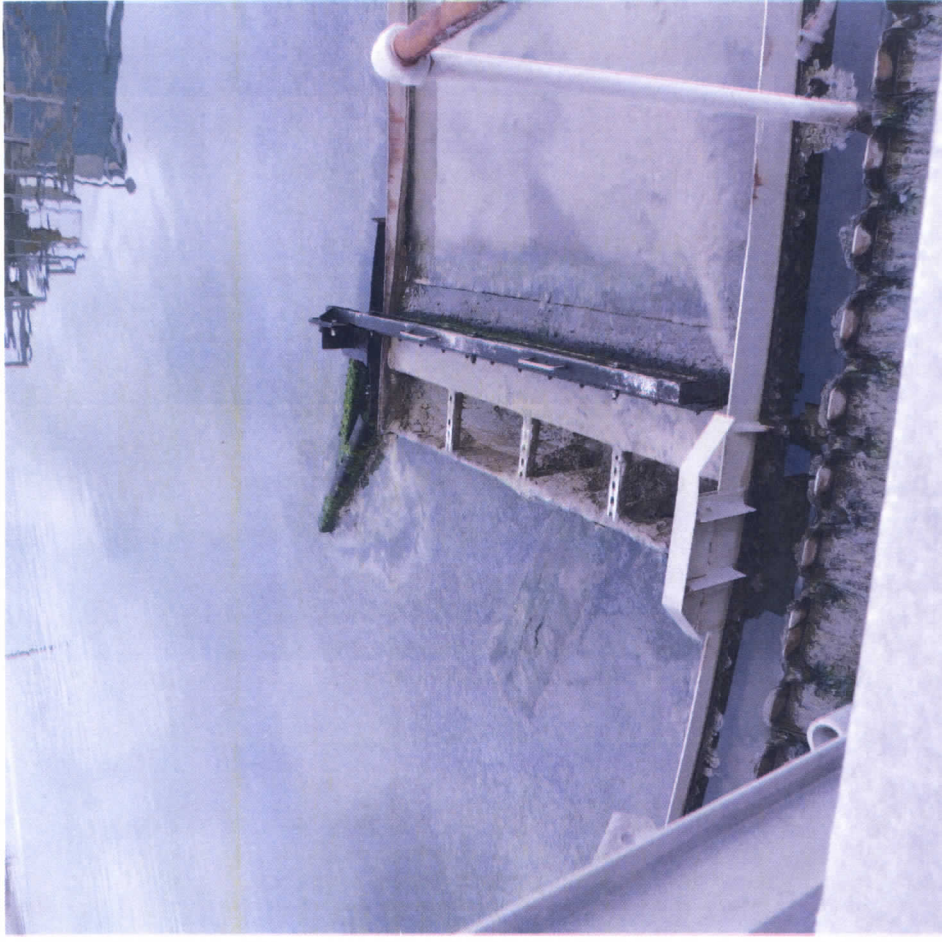
DSCN6795 – scum being collected at “beach” in the final clarifier

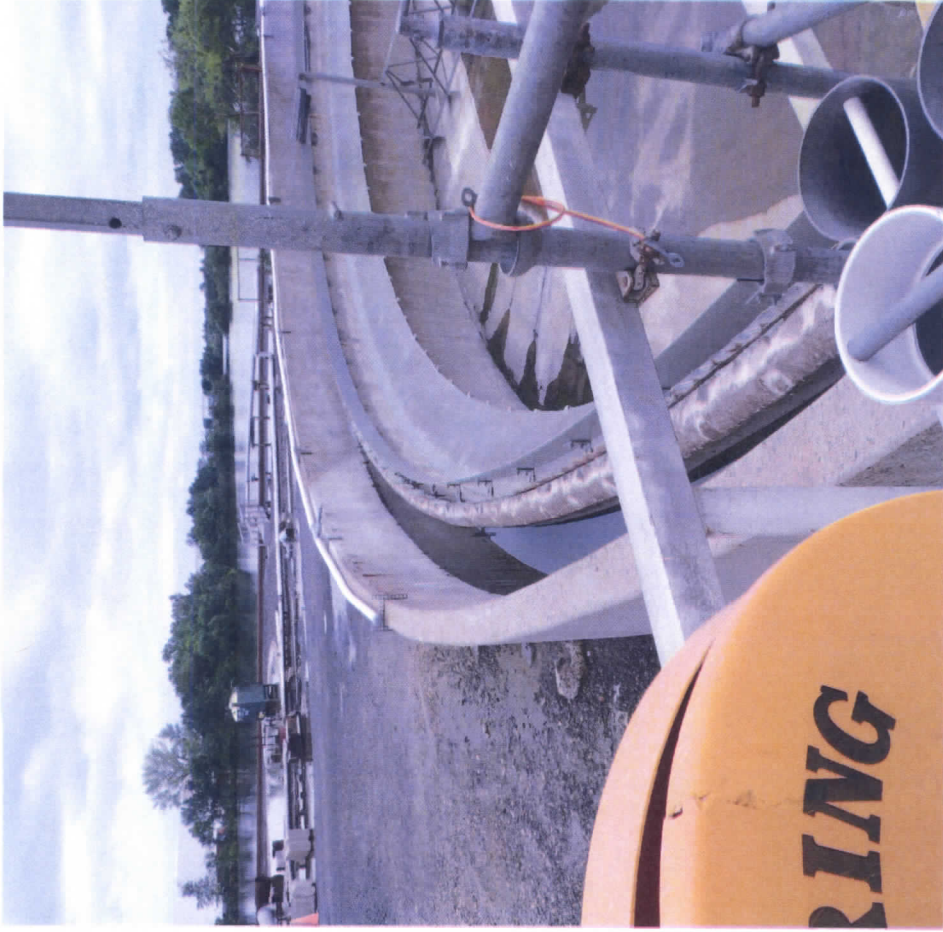
DSCN6798 – Final Clarifier No. 3 is down for maintenance

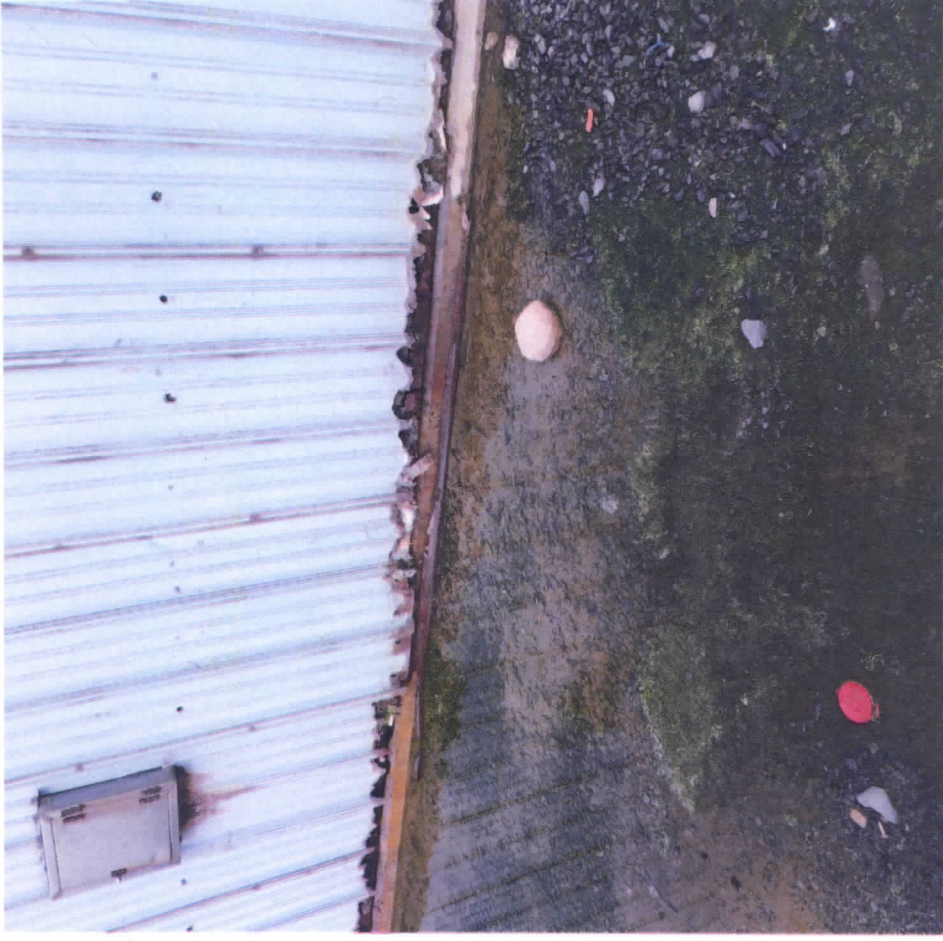
DSCN6799 – Final Clarifier No. 3 down for maintenance

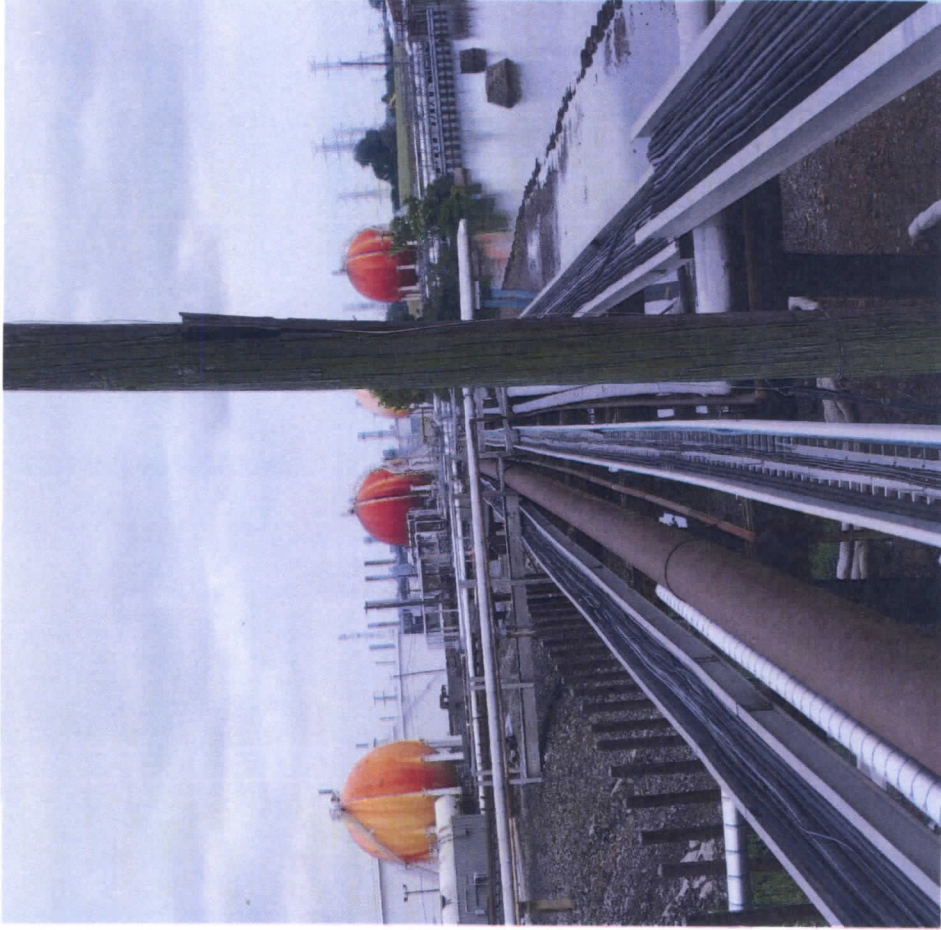
DSCN6810 – unstabilized soils along the bank near pipeline in vicinity of WWTP effluent – Outfall 002

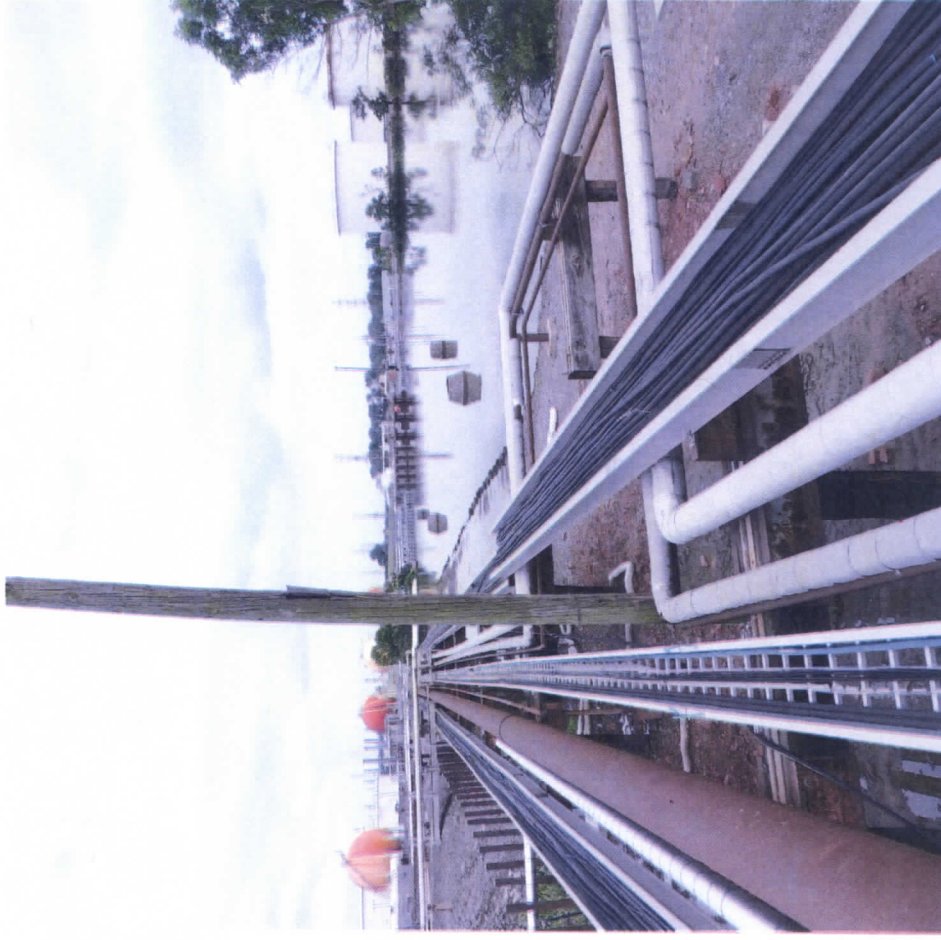
DSCN6811 - unstabilized soils along the bank near pipeline in vicinity of WWTP effluent – Outfall 002

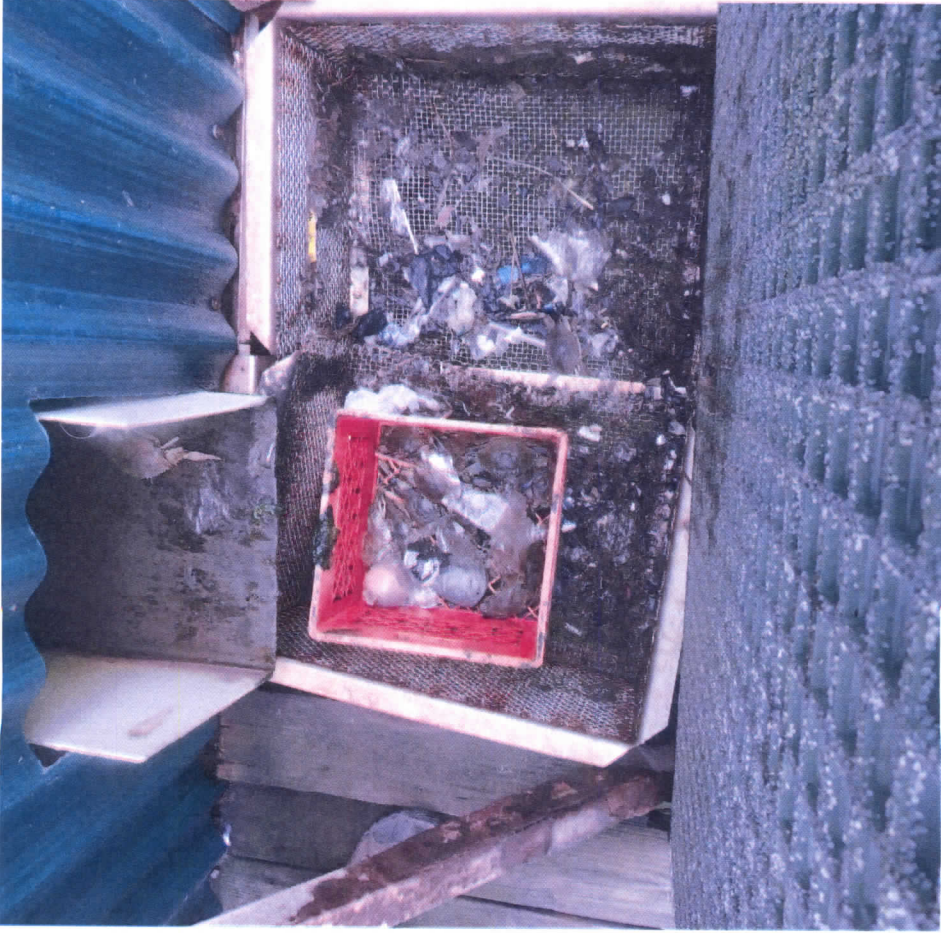
DSCN6877 – impinged shellfish collected in crate next to
Arthur Kill pump house screens

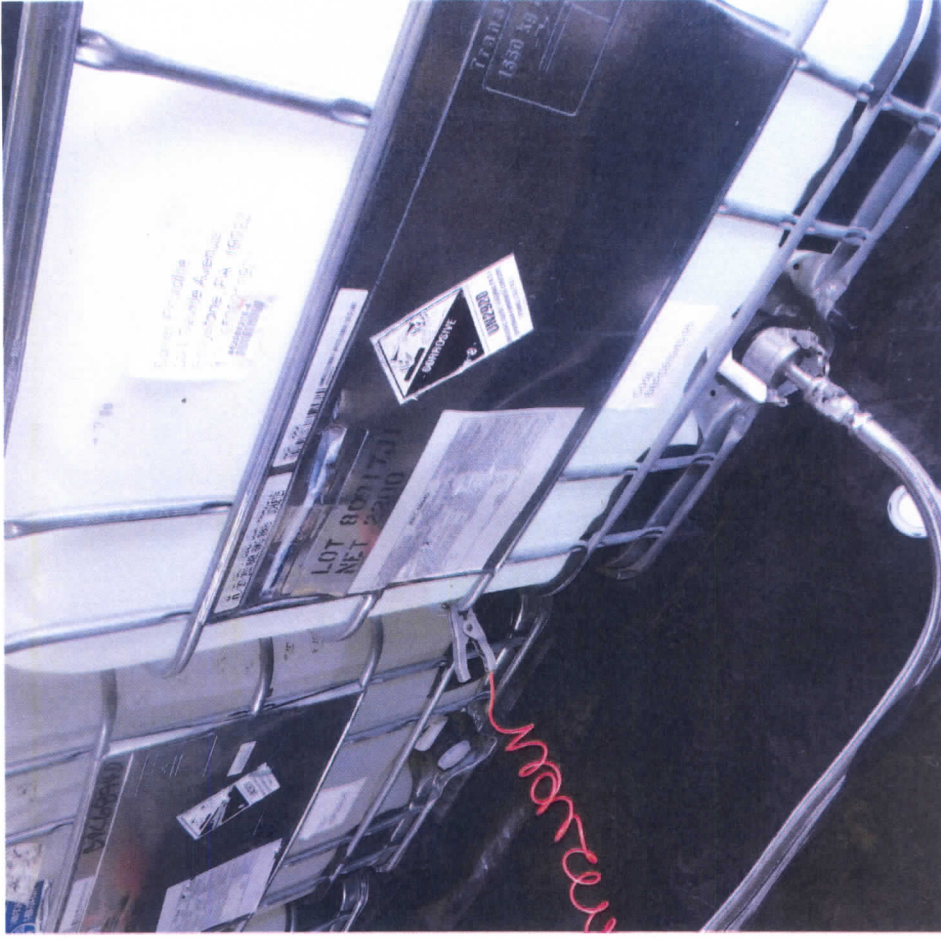
DSCN6880 - Clam Trol Biocide BPC 68940

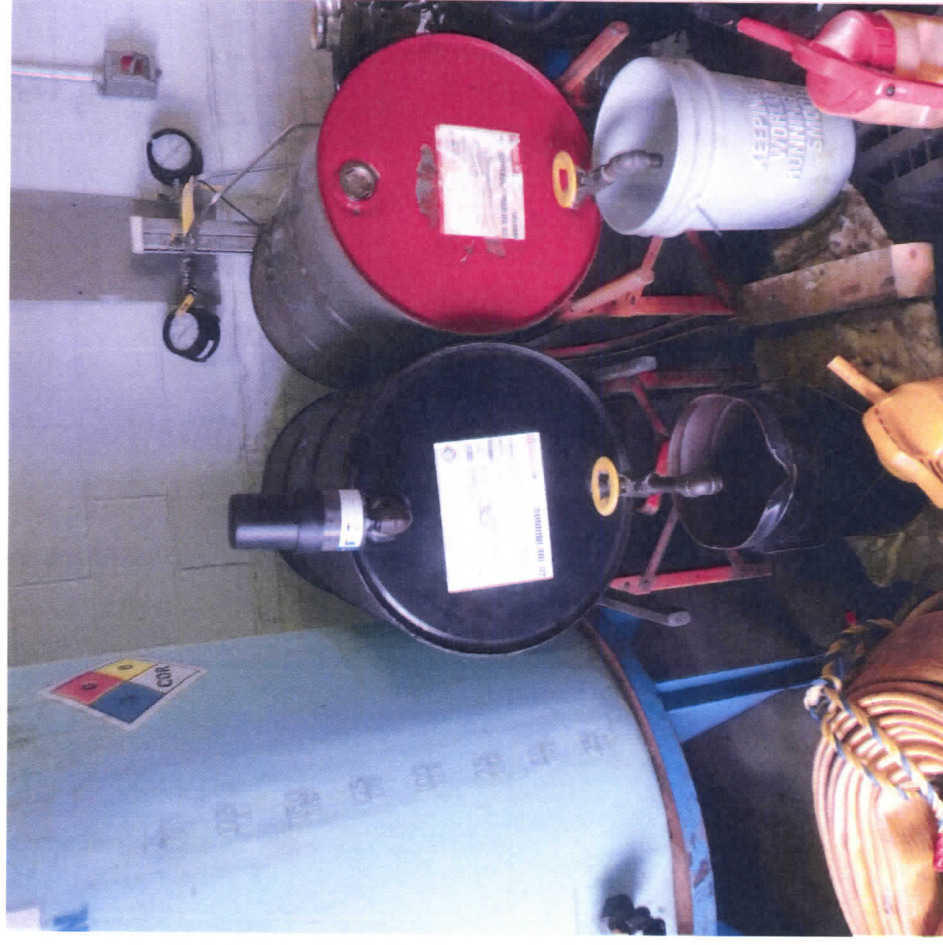
DSCN6882 – oil drums at Salt Water Intake Pump House

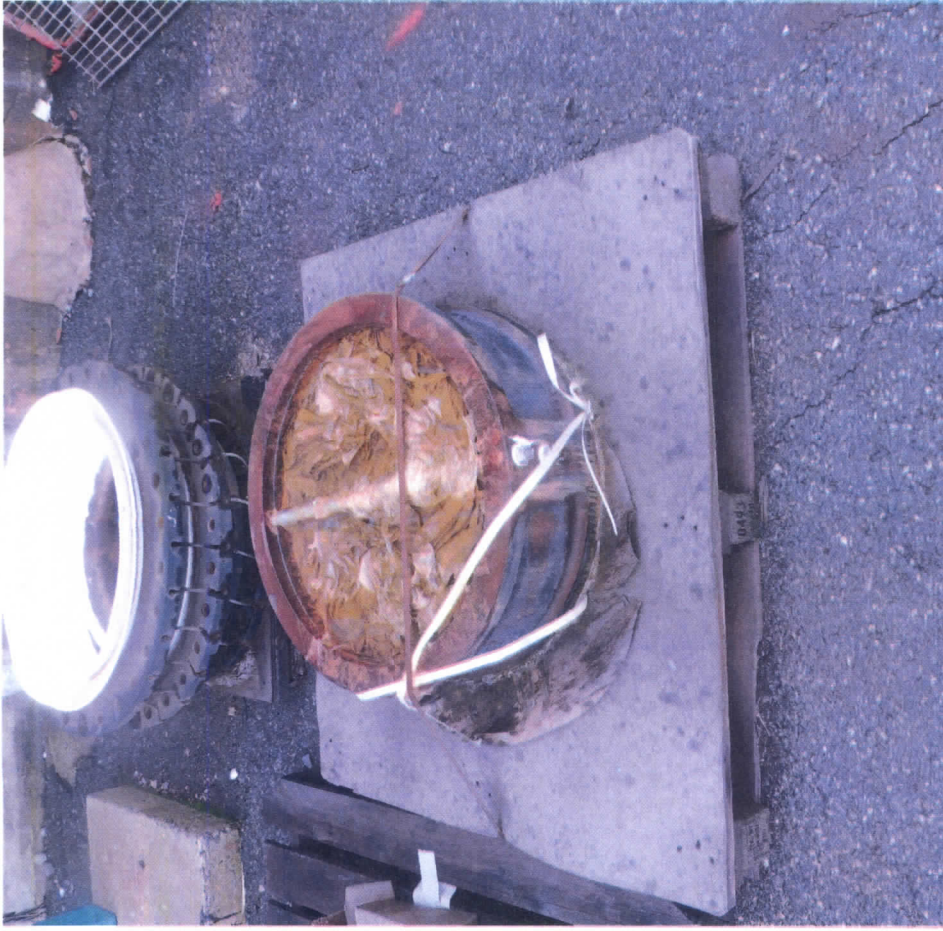
DSCN6883 – debris outside near intake Arthur Kill (Salt Water) Pump House

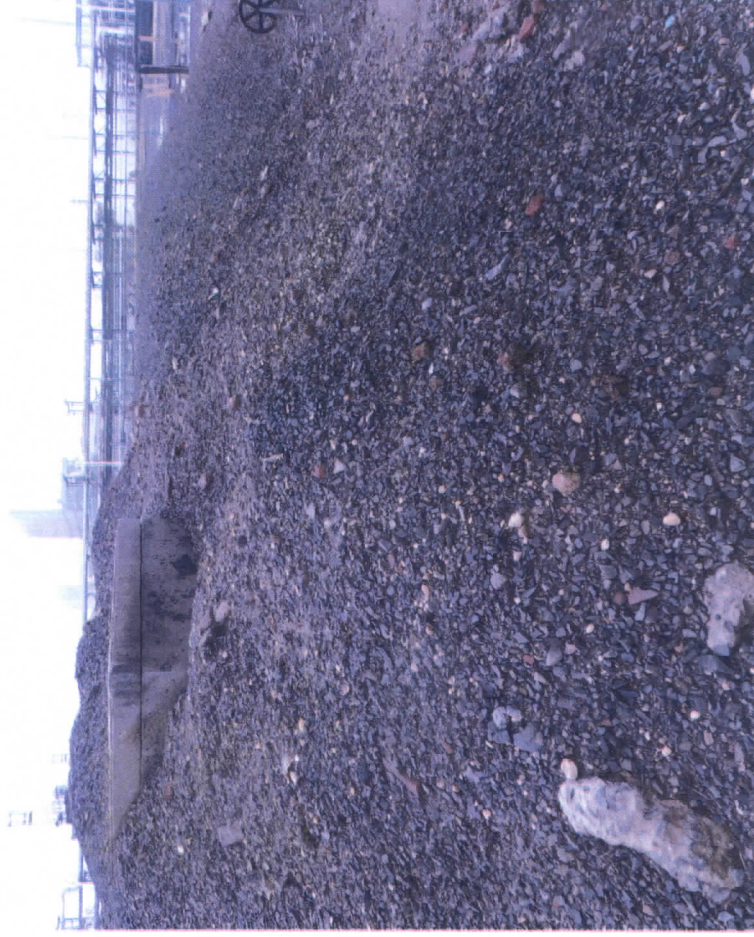
DSCN6884 – leach field for Arthur Kill (Salt Water) Pump House sanitary wastewater

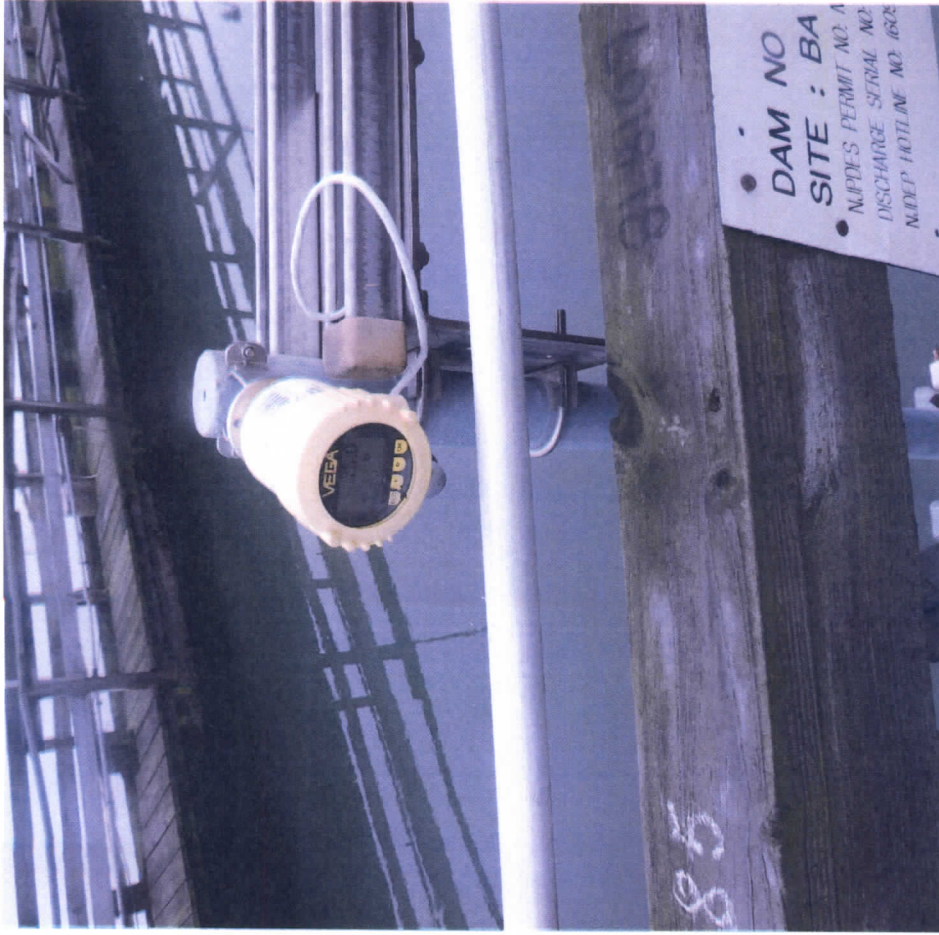
DSCN6891 – upstream ultrasonic at Outfall 001 read 75.0 inches

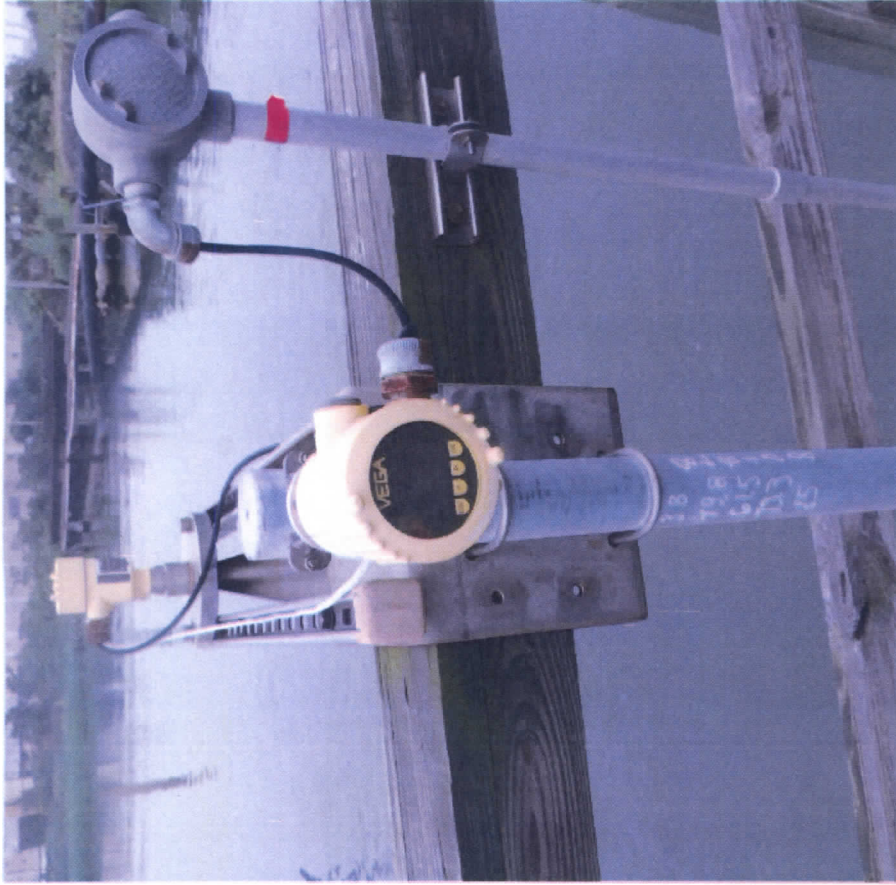
DSCN6892 - Display for downstream ultrasonic flow meter at Outfall 001 – read 72.0

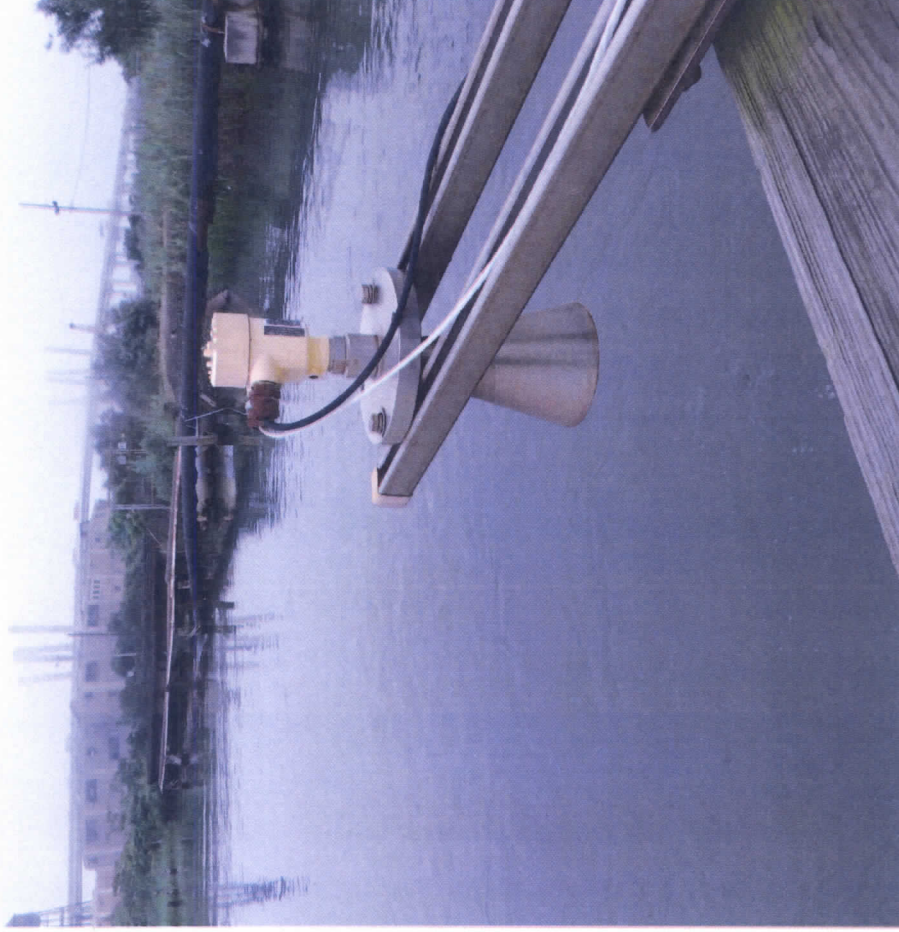
DSCN6893 – Ultrasonic flow meter on downstream side of underflow baffle at outfall 001
